# **REAL-TIME MONITORING OF A MULTIPLE RETROGRESSIVE LANDSLIDE**

**A Thesis Submitted to the  
College of Graduate Studies and Research  
in Partial Fulfillment of the Requirements for the  
Degree of Master of Science  
in the Department of Civil and Geological Engineering  
University of Saskatchewan  
Saskatoon, Canada**

**Chad Dennis Salewich**

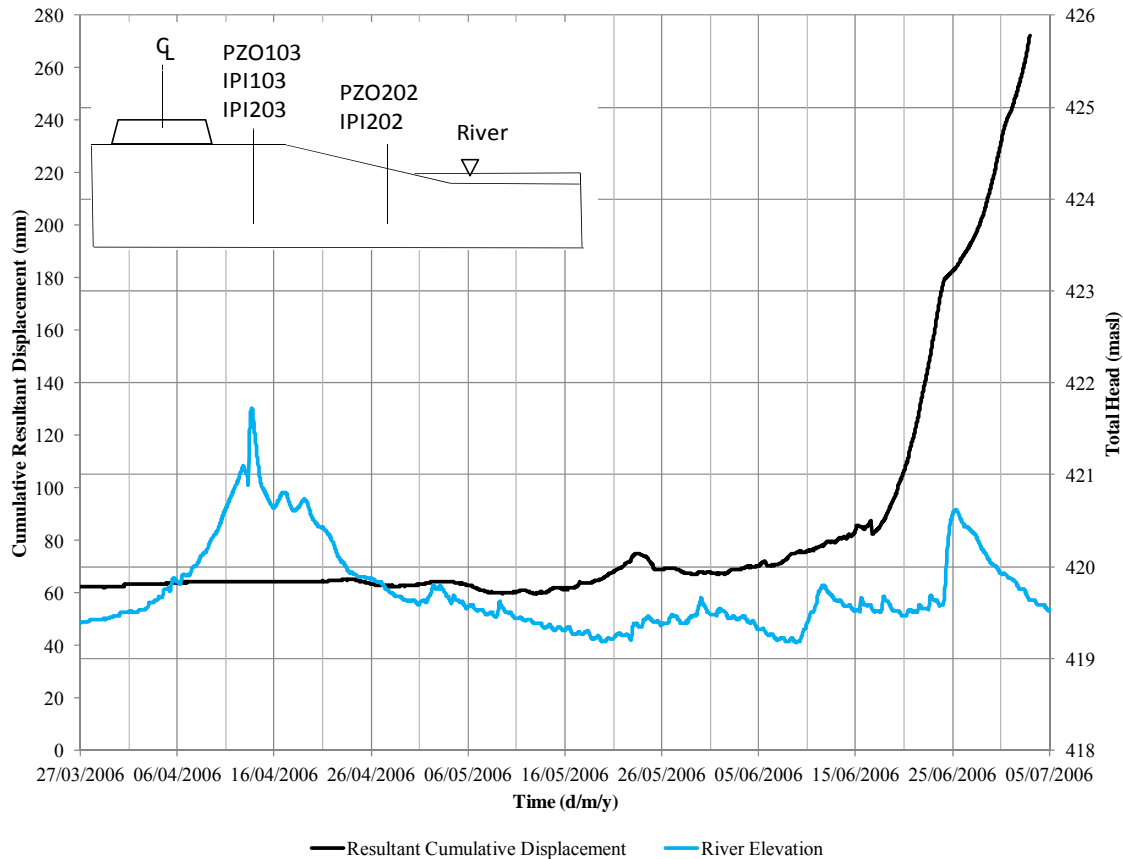
suggests that displacement of the landslide was triggered by river bank erosion due to higher seasonal flows or alternately a rapid drawdown mechanism.

**Figure 5.5: Resultant cumulative displacement at IPI202 and river level during spring and early summer 2006 to highlight a potential rapid drawdown mechanism.**

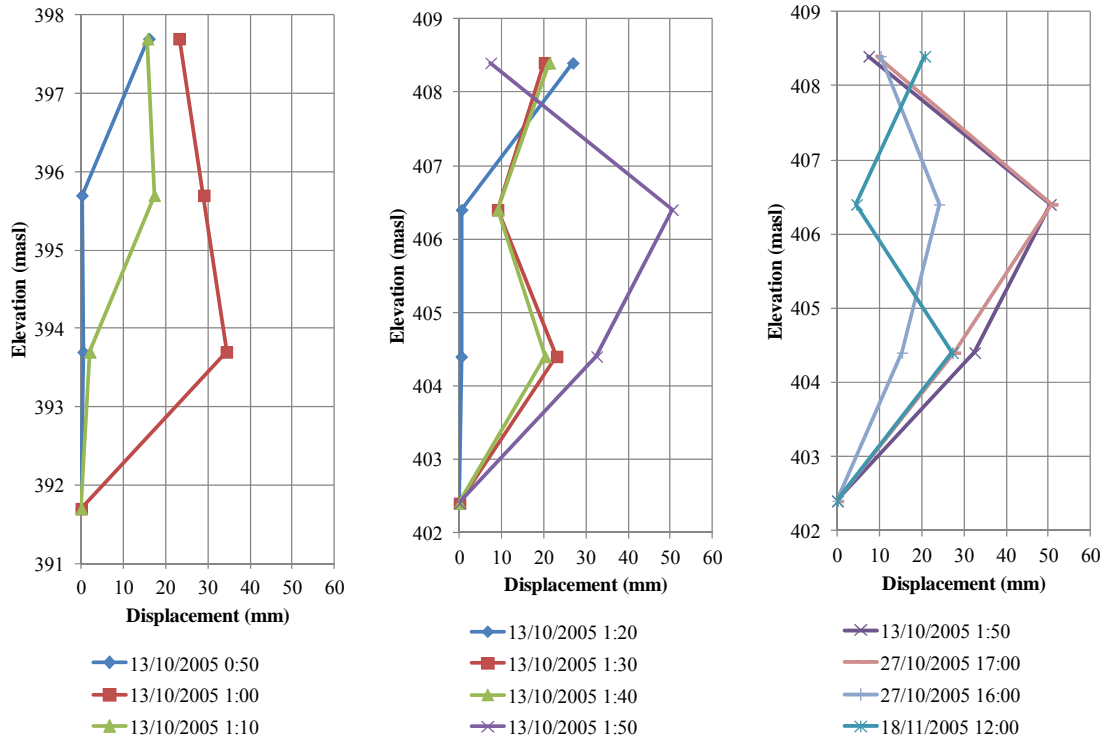
On October 13, 2005, 25 days after installation of the IPIs, a major disturbance in the readings at both the crest and toe of the slope occurred. After this disturbance the crest was moving at greater rates than the toe. The initial disturbance was attributed to a settling of the head assembly of the IPIs triggered by global failure of the slope. Additional disturbances were noted in the IPIs at the toe of the slope and attributed to the casing contacting the IPIs. A geometric analysis was developed to verify that the unexpected movement could have been caused by the casing contacting the IPIs. The geometric analysis included observation of the shear induced deformation profile of the slope inclinometer casing, IPIs diameter, IPIs length and the annular space between the casing and the IPIs. The geometric analysis verified that the IPIs at the toe of the slope were likely affected by the IPIs coming into contact with the casing. Casing contact could affect the IPIs orientation and depth position, resulting in unexpected data.

**Figure 5.9: Displacement profiles during the movement on October 13, 2005 for IPI103 (left) and IPI202 (center), and further disturbances of IPI202 during fall (right).**

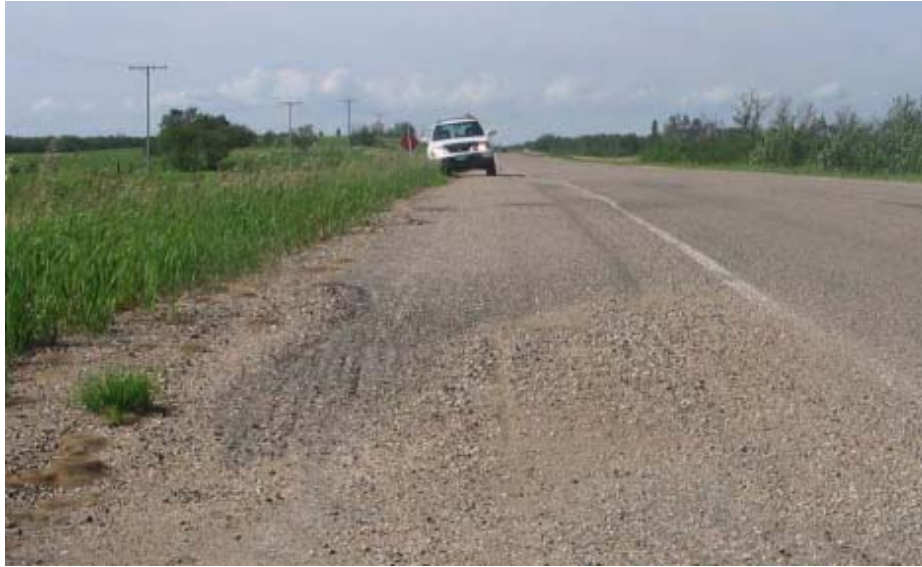
**Figure A. 1: Highway No. 302 looking west, August 2005, landslide intersecting the highway near the red sign (Photograph courtesy of Saskatchewan Ministry of Highways and Infrastructure).**

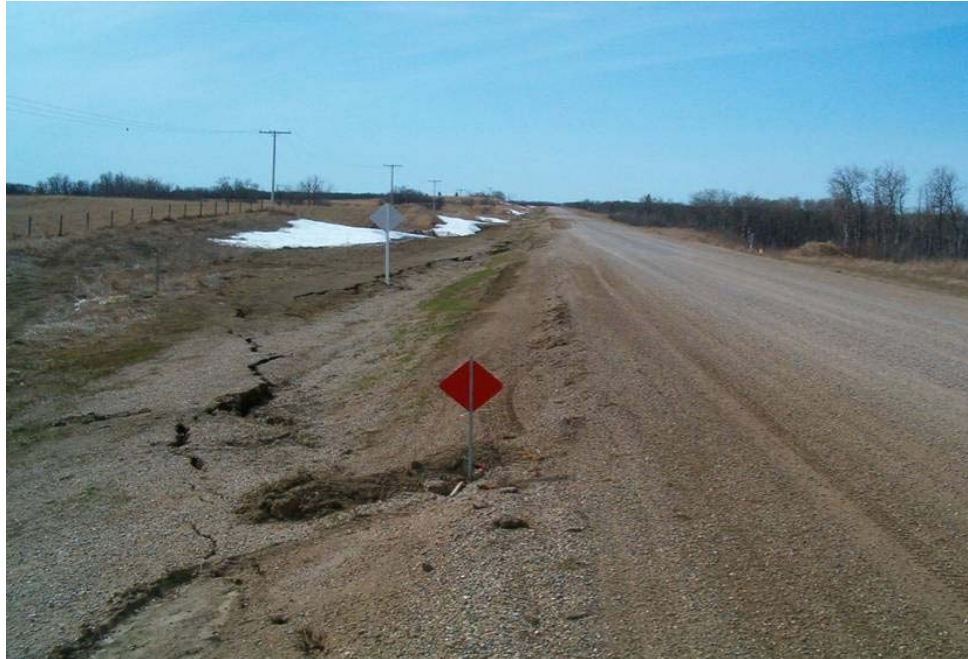
**Figure A. 3: Highway No. 302 looking west Spring 2006, highway converted to gravel for maintenance purposes (Photograph courtesy of the Saskatchewan Ministry of Highways and Infrastructure).**

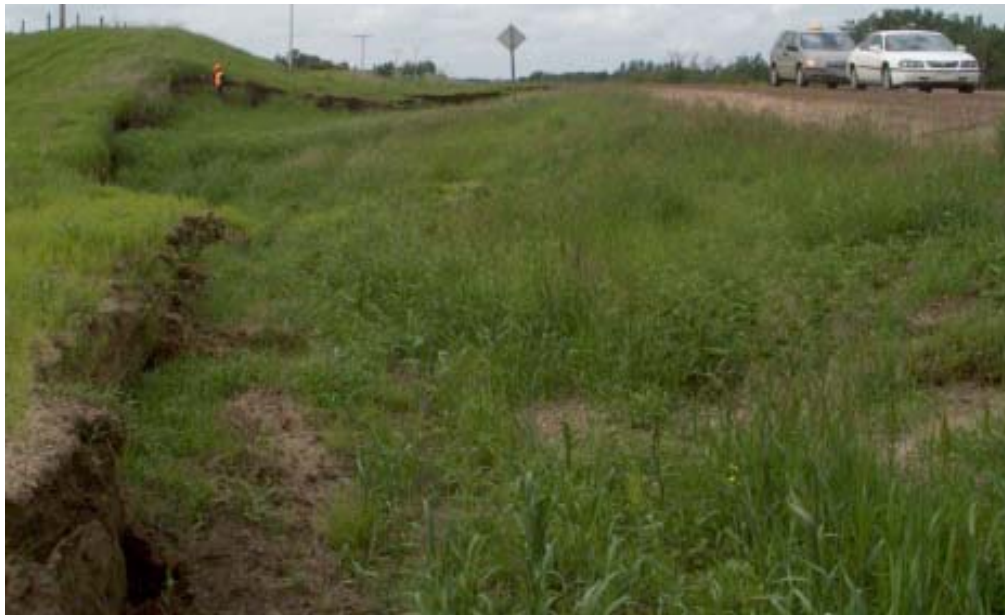
**Figure A. 4: Development of main scarp June 2006 (Photograph courtesy of the Saskatchewan Ministry of Highways and Infrastructure).**

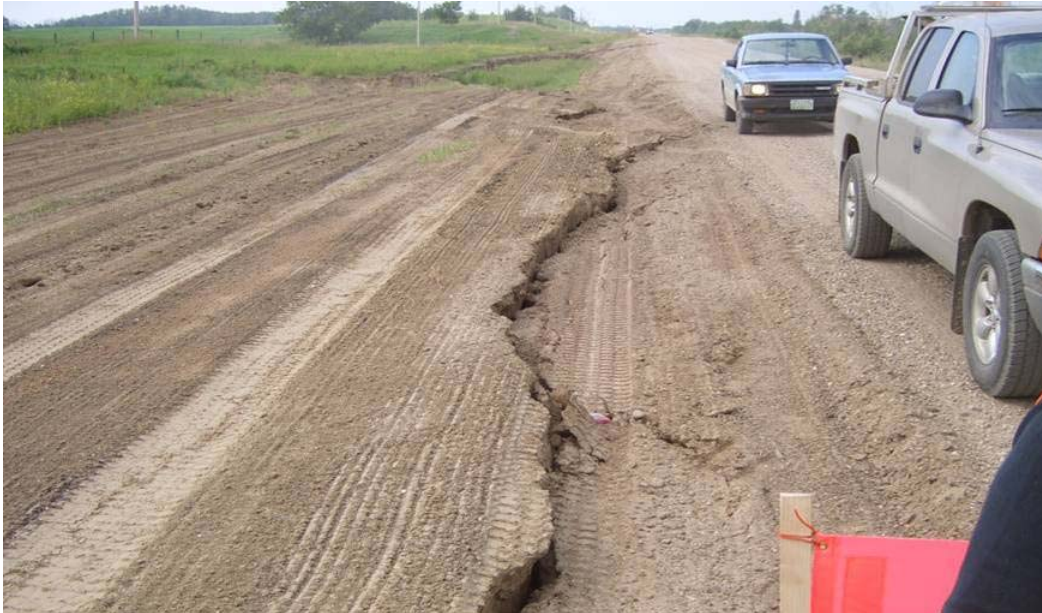
**Figure A. 5: Grading of scarp and continued maintenance of roadway to protect public as highway was still in use (Photograph courtesy of the Saskatchewan Ministry of Highways and Infrastructure).**

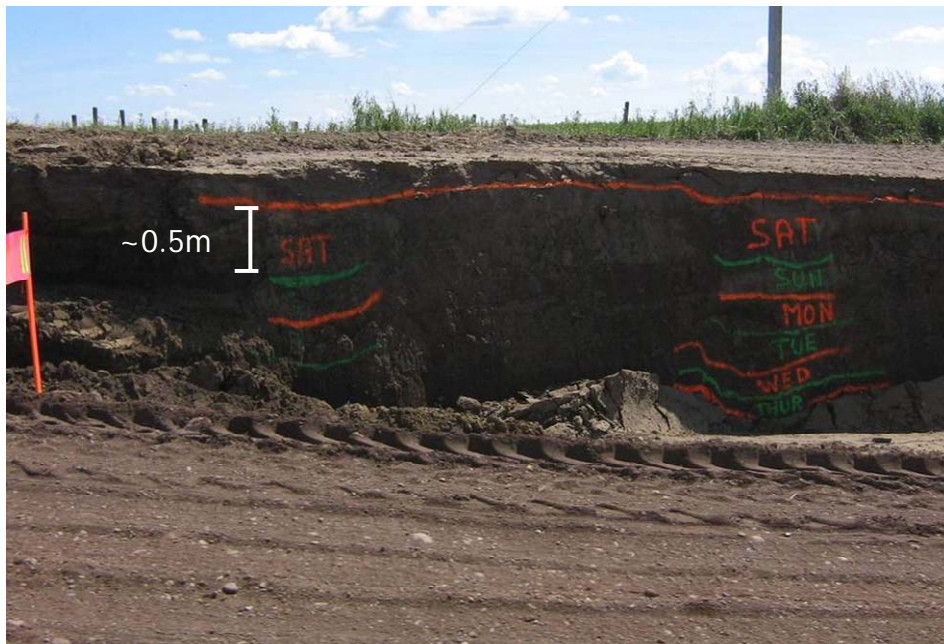
**Figure A. 6: Movement at head scarp measured per day in mid-July 2006 (Photograph courtesy of the Saskatchewan Ministry of Highways and Infrastructure).**

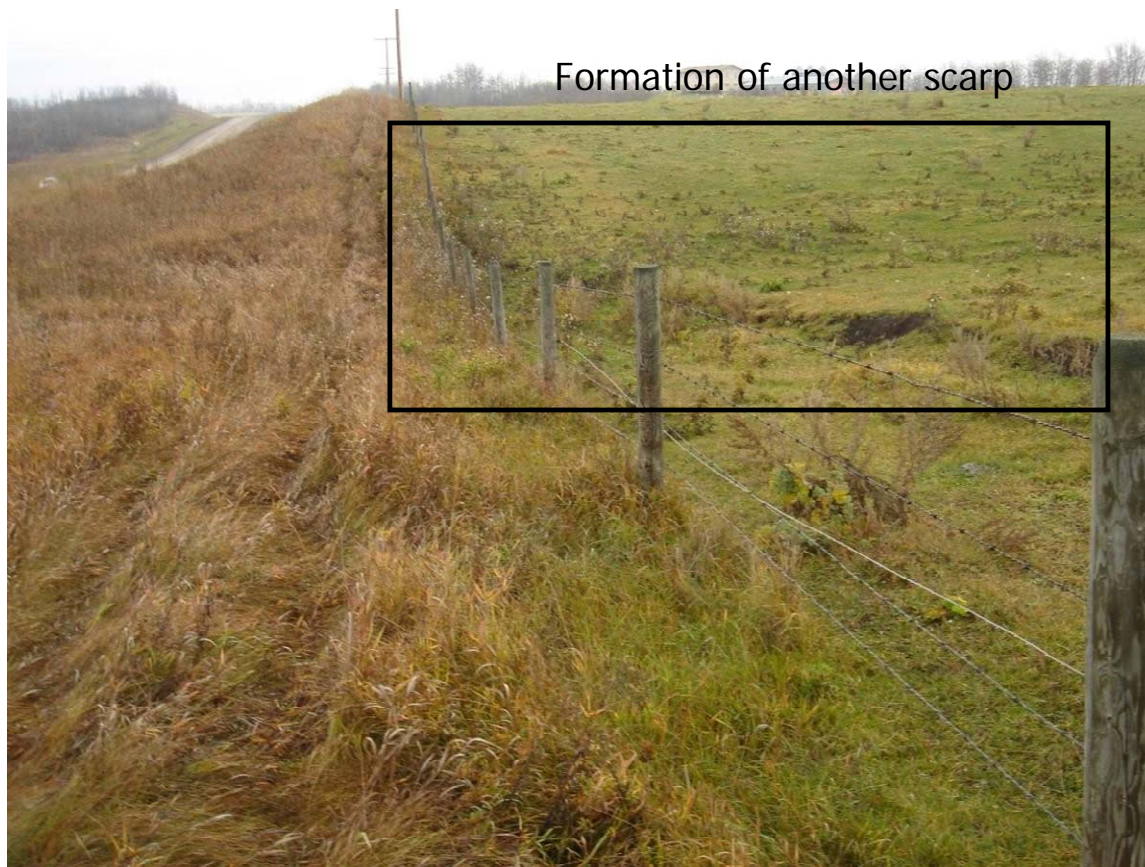
**Figure A. 9: Formation of a new scarp now entering a rancher's field mid-October 2007 (Photograph by Chad Salewich).**
